ULNRC-06042

**DOCKET NUMBER 50-483  
CALLAWAY PLANT UNIT 1  
UNION ELECTRIC CO.  
FACILITY OPERATING LICENSE NPF-30  
LICENSEE EVENT REPORT 2013-008-00  
ARCING IN ISOPHASE BUS RESULTS IN A GENERATOR TRIP,  
TURBINE TRIP, REACTOR TRIP AND A SMALL FIRE**

**4. TITLE**  
Arcing in isophase bus results in a generator trip, turbine trip, reactor trip and small fire

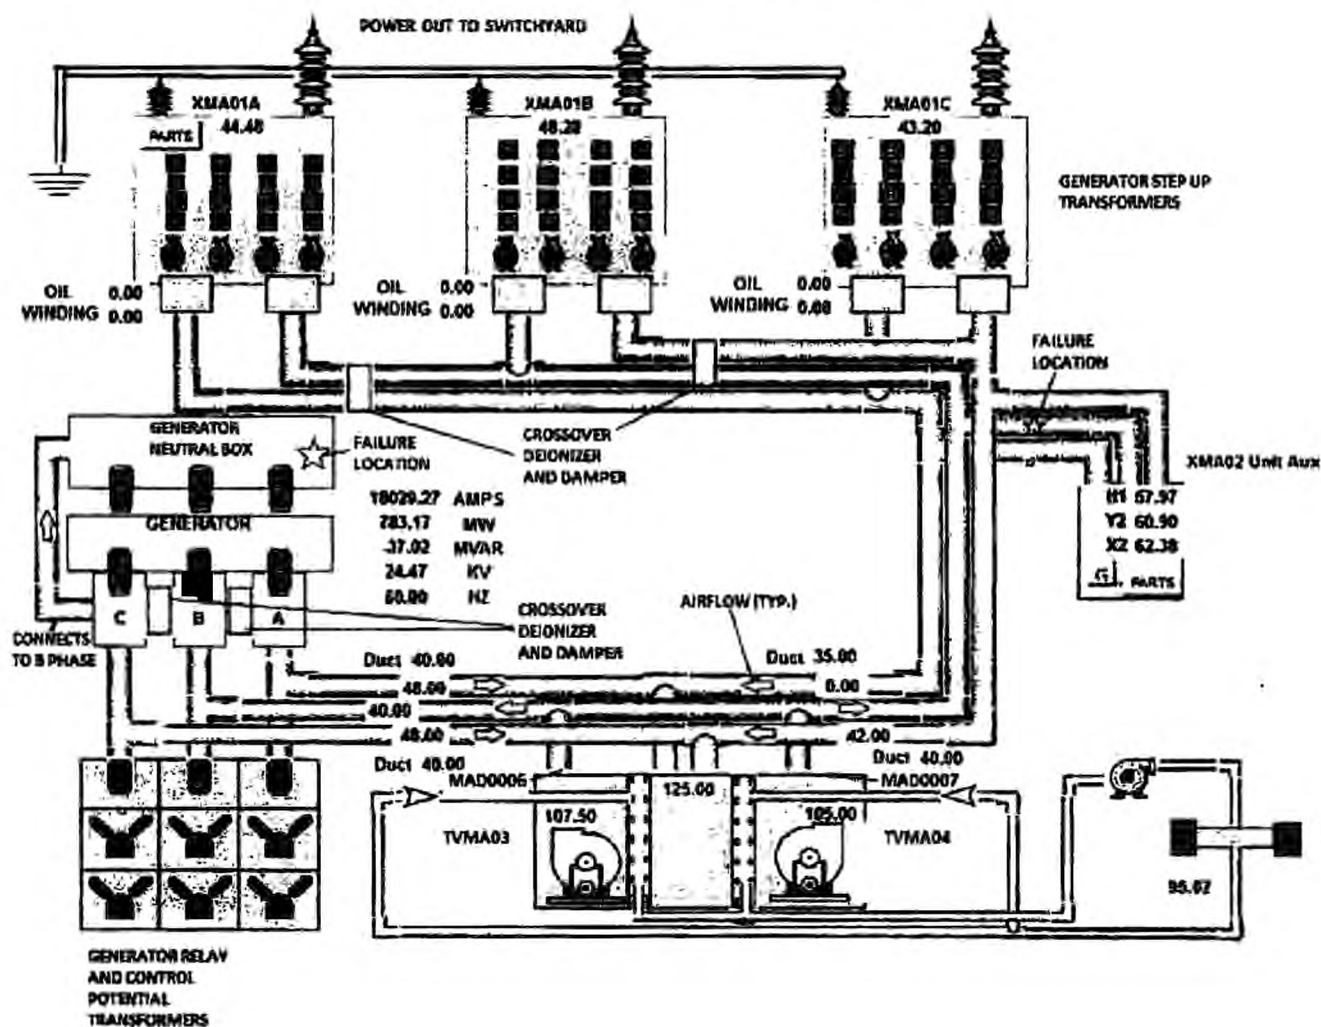
### Simplified Diagram of the Isophase Bus System

As shown in the diagram at the end of this document, this system incorporates a water-cooled, forced air cooling system to cool the bus conductors heated from the large currents flowing in the high voltage bus bars within the bus ducts. Two redundant fans, cooling coils, and associated dampers make up the cooling skid. Forced air from the fan(s) enters the "B" phase isophase duct and splits to flow toward the main generator and the main transformers. Return crossovers are located at the main generator high side connection box and at the main transformer bus work to return airflow through the "A" and "C" phase isophase ducts to the air to water heat exchangers located at the fan suctions. Back-draft dampers are located on the fan discharge.
